## Rudder removal and installation, HR312 S/N 568

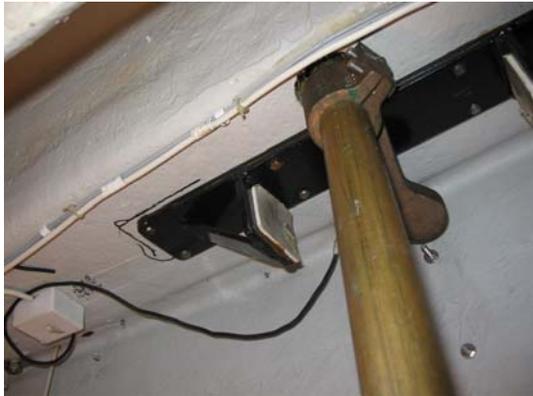
Start by removing the tiller at the top of the rudder shaft. Then remove all the things attached to the shaft within the hull. There’s a steering stop near the top (picture below) and perhaps an autopilot attachment. If you have wheel steering there’s also a bell-crank for the steering cables. The grease stuffing box/rudder shaft bearing (second picture below) does not have to be removed. The rudder shaft will eventually have to be pulled upward so that the rudder may be removed aft.

To remove the steering stop (or limiter), loosen the 2 bolts and slide the stop arm downward. There’s a locking key made from steel that prevents the arm from turning on the shaft. You may leave the arm halfway down the shaft.

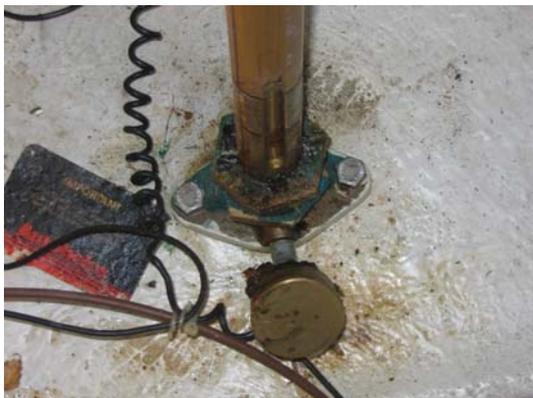
The cavity where the nut is found is covered with fibreglass putty. Use a lightweight hammer and small chisel to remove this. Be careful not to damage the gelcoat surface of the rudder. The upper rudder fitting does not have to be removed so unless the putty covering the tangs that attach it to the rudder is cracked and you want to replace it, you may leave it as is. The cracks will probably also hold

a bit of water that takes some time to dry out. My guess is that since the upper fitting is the thing that actually transfers the turning torque from the shaft to the rudder blade, the putty covering the tangs may crack with time. This is only cosmetic though.

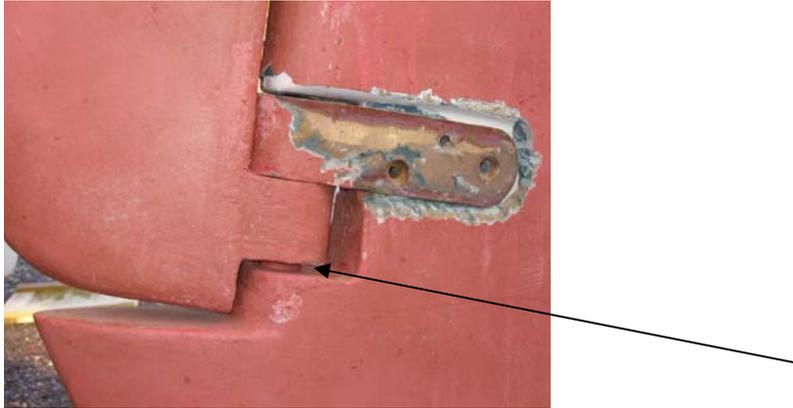
The aft lower fitting is attached to the rudder by 3 screws that extend through the rudder, from one tang to threads in the other, two from left to right and one from right to left. The putty covering these will also have to be removed. These screws are of a fairly large diameter and the screw slots are a little less than 3 mm wide and 15 mm long. You will need a screwdriver that fits the slots as exactly as possible and to which you can attach a wrench for maximum turning torque. You may also need an assistant preventing the rudder from turning when you apply pressure and torque to loosen the screws. Only loosen the screws at this time, do not remove them.

This picture also shows the hinge pin resting on a “ledge” which is part of the rudder (the skeg is to the left). This means that the pin will fall out of the fitting when the rudder is removed aft. The lower fitting itself will also drop to the ground once the pin falls away.

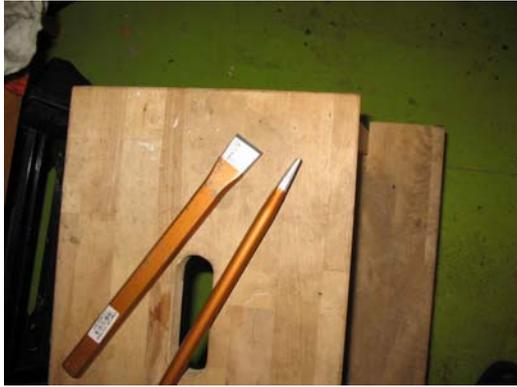
Unscrew the nut so that it is a little lower than flush with the end of the shaft. It's better to use the nut to take the force applied, than the shaft and thread. Brass is not as hard as steel. Protect both the rudder GRP part and the nut by pieces of steel sheet metal or something similarly solid. Basically what you want to do is to pry the rudder shaft out of the upper fitting. I used two flat chisels whose sharp ends were flat and wedge shaped (see picture below). I entered one from each side and used a hammer to force the chisels inwards. The cone shaped shaft having been in position for a long time needed a sharp “crack” to let go of the inside of the fitting and start moving upwards. As I've only seen one rudder installation it's possible that the gap, or rather the distance between the GRP and the shaft, is not the same. You might need more material to fill the gap so that the chisels will be able to pry the parts apart. Also, try to center the force you apply straight along the axis of the shaft so that it doesn't bend. The brass shaft is not solid as steel. I think I bent the threaded portion of my yacht's rudder shaft just a little.

My steel chisels are 12 mm thick each.

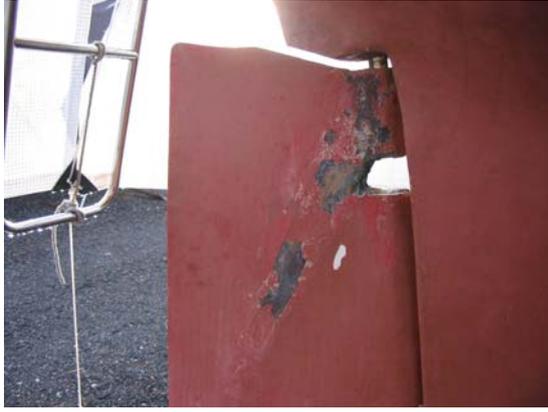
This is what it looked like once the shaft was pushed upwards with the threaded bottom end out-of-sight into the upper fitting.

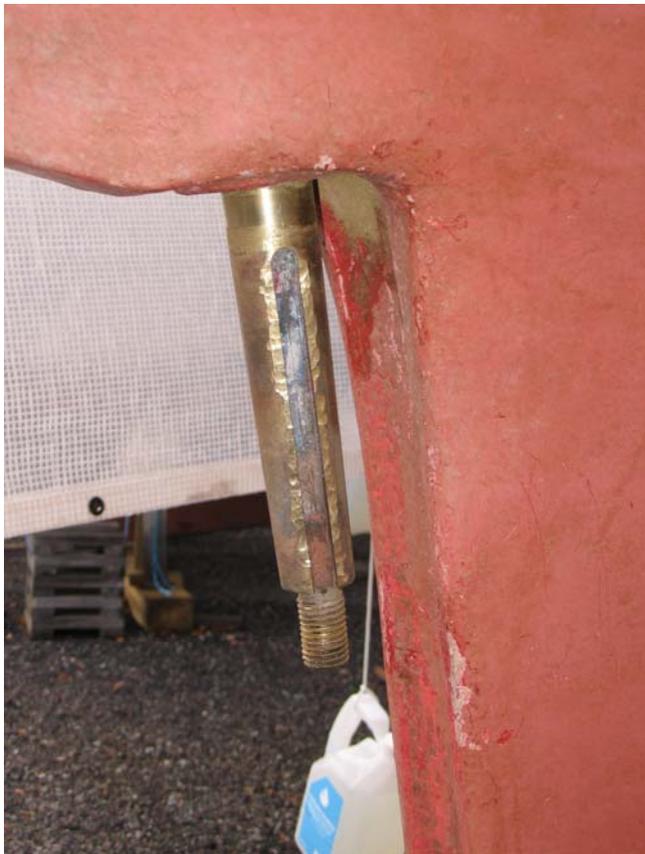
This picture shows what the shaft looked like once the rudder was removed. The shaft is rotated 90 degrees for visibility. As you notice, the shaft surface was a little damaged by the rotating file but I don't think it matters much. The locking key did not want to let go of the axial slot and I could not think of any other way to do it.

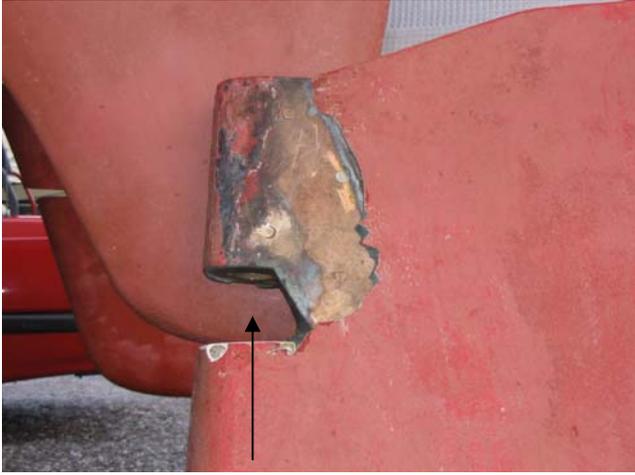
This shows the rudder as removed. Looking closely the vertical slot for the locking key is just visible along the forward edge of the hole.

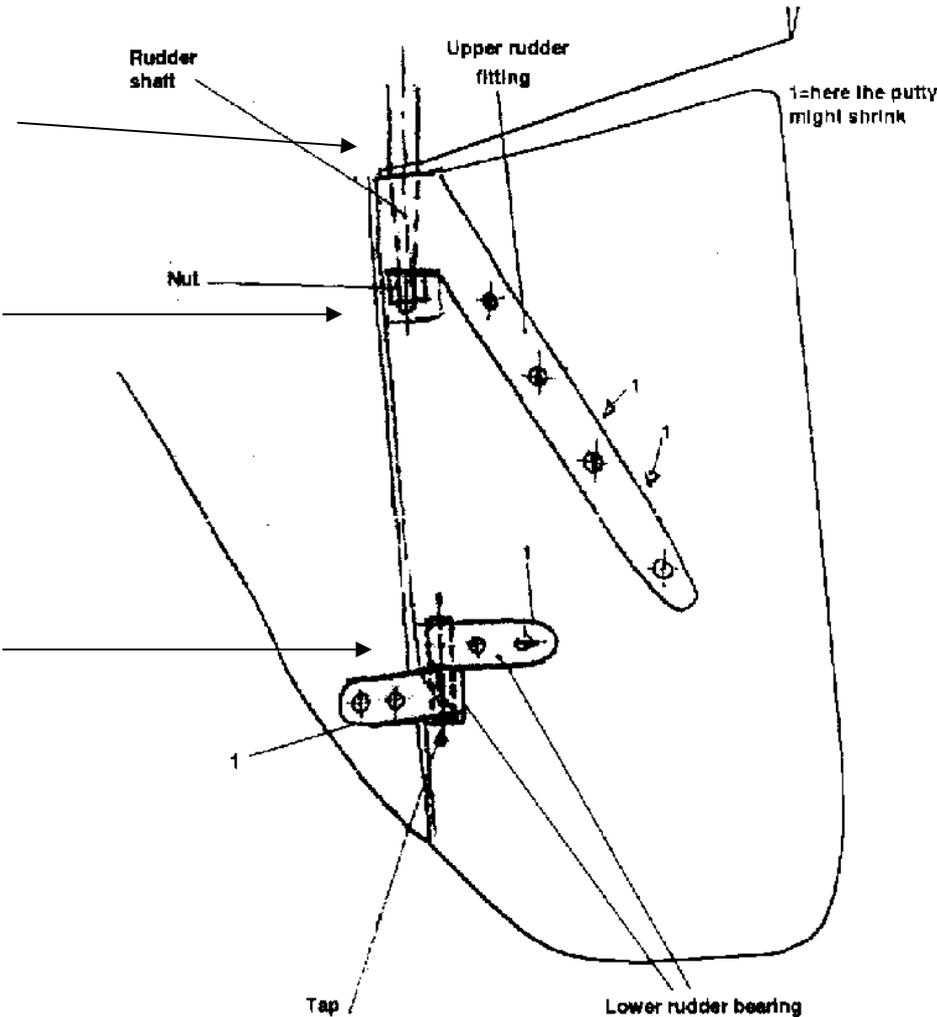
The sketch below was sent to me from Hallberg-Rassy. The term "Tap" is an inaccurate translation from Swedish and should really be pin.

I've added 3 arrows.

The top one indicates the stuffing box/lower hull rudder shaft bearing inside the hull.

The second arrow down indicates the cavity with the nut and split pin.

The third arrow down indicates the lower fitting.
