Cutlass Bearing Removal HR40, HR43 & HR48

(Stern tube construction from 2007 with composite/rubber bearing)

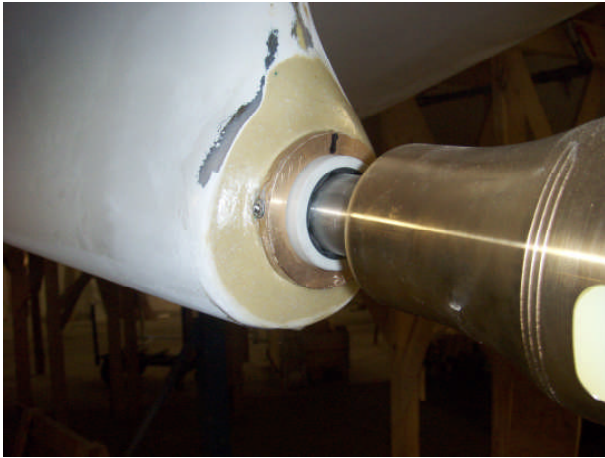
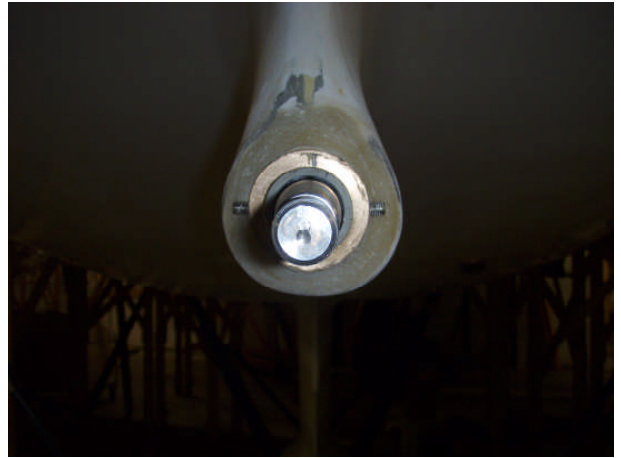
Step 1: Remove propeller and loosen 2 x allen screws.

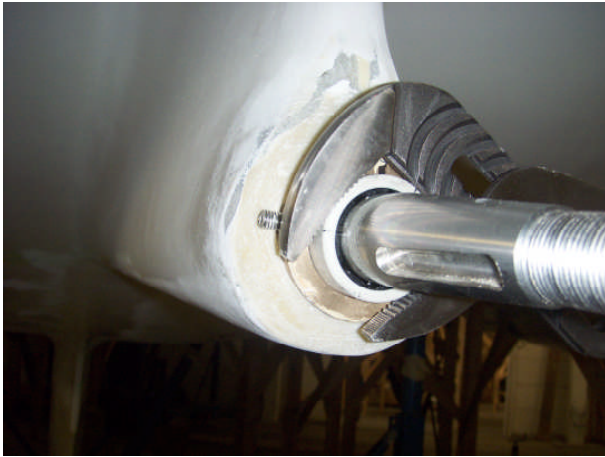
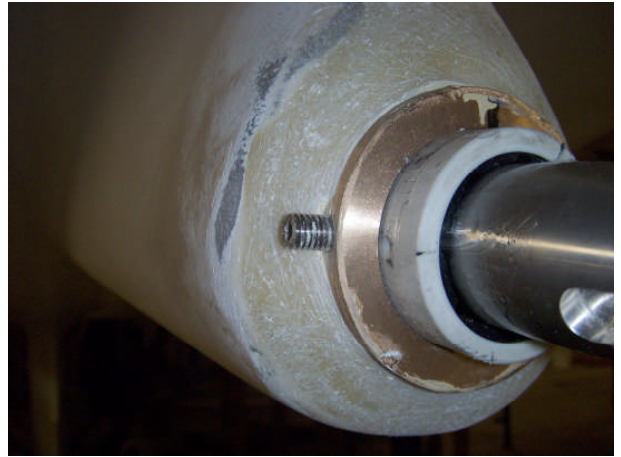
Step 2: Grip the cutlass bearing's composite outer sleeve, rotate and pull to remove.

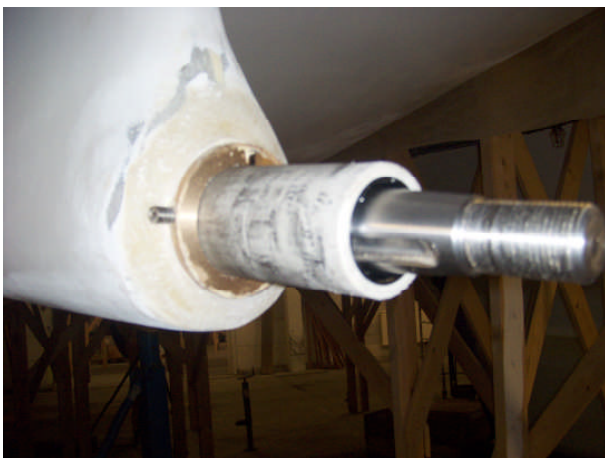
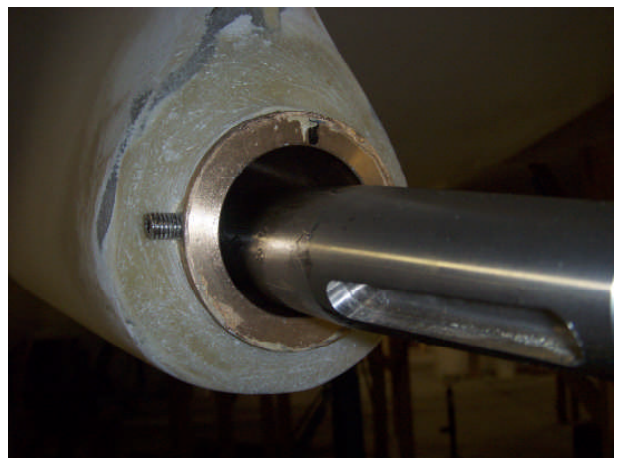
Step 3 : Remove bearing and replace. Pls. note: do not allow propeller shaft to hang in stern tube; risk of damage to gearbox shaft!
